MEMORANDUM

Elliott House Rehabilitation [1904 North Heliotrope Drive, Santa Ana]
Project Compliance Analysis [U.S. Secretary of the Interior Standards for Rehabilitation]

13 November 2023

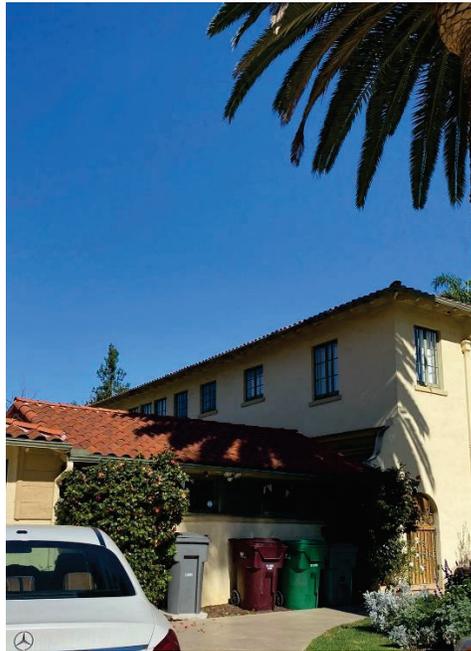
Image 02: Front façade of the existing pool room as viewed from street/driveway.

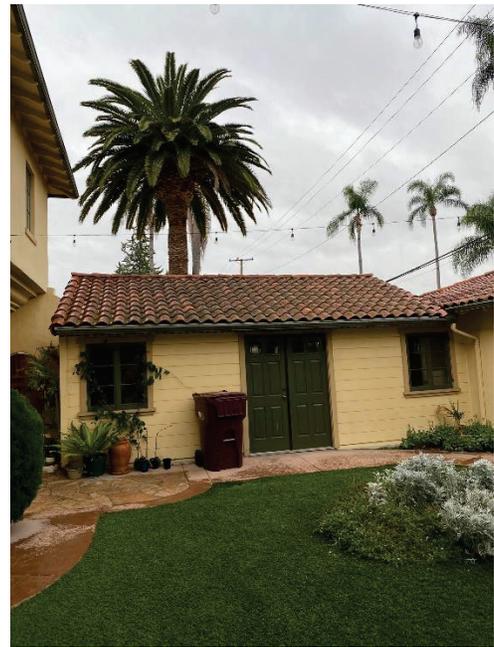
Image 03: Rear façade of the pool room as viewed from the rear yard.

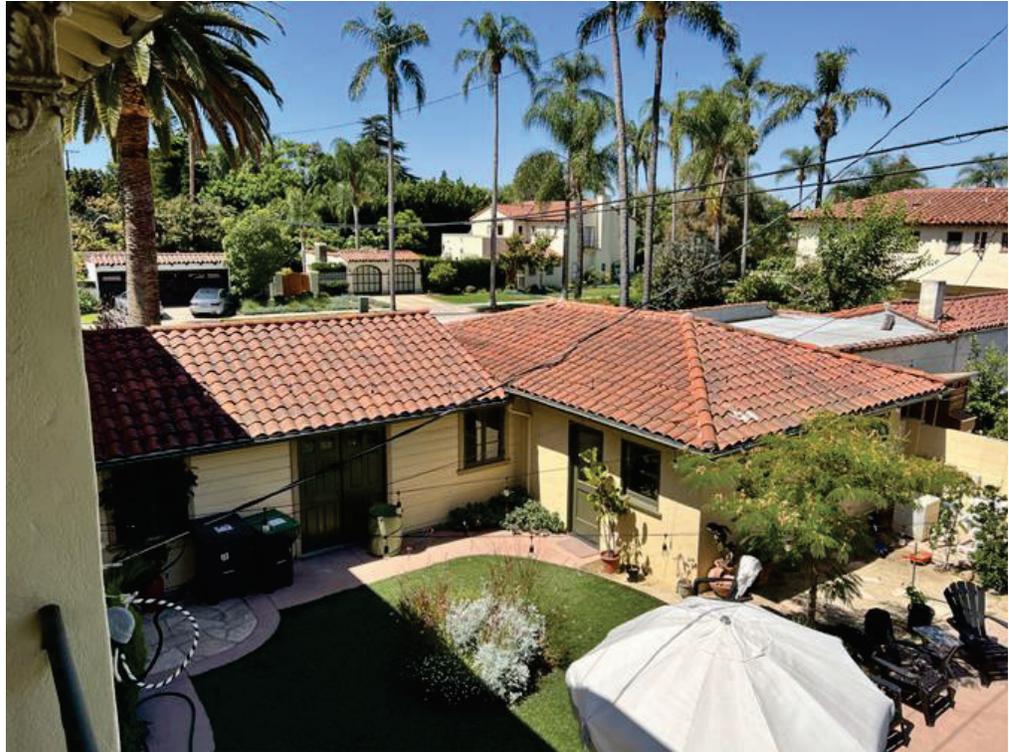
The western gable of the pool house building rests on the rafter tails of the adjacent garage, rather than a traditional bearing wall. These alternative construction methods cause concern toward the structural stability of the building.

Image 04: The existing pool house building and garage as viewed from the west second-story loggia.

The project also includes extending the roof ridge of the pool room building to connect with the adjacent garage. This change will eliminate the existing disconnection of roof forms and improves the water tightness of both buildings. The building's doors and windows will be removed with the exception of those on the eastern façade. The existing clapboard siding will be replaced with textured stucco, matching the house and garage. The existing applied trim detail of the building will be utilized for both the existing and new fenestration.

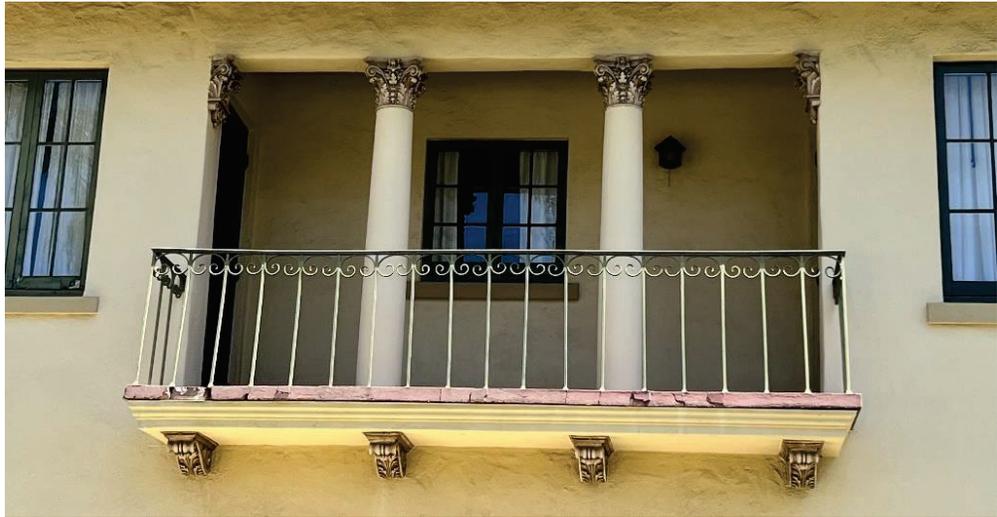
Image 07: South Loggia: The most prominent of the home's second floor balconies includes decorative classical detailing and iron railing. Material losses to the coping are evident.

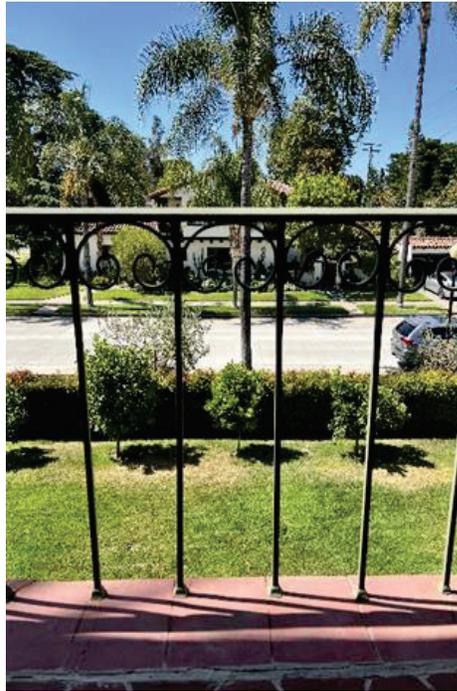
While the balcony decorative wrought iron railings appear to be in relatively good condition, they do not conform to today's safety regulations in both its height and openings. Failure of the existing paint coating was also observed throughout. The existing coating also contains lead. Oxidation has occurred where the railing penetrates the coping edge, resulting in spalling of the adjacent concrete decking. Previous repairs to the terra cotta paving have resulted in negative sloping of the deck preventing proper runoff of moisture from the deck surface.

Image 11: The decorative wrought iron rail does not conform to today's safety regulations, creating a potential safety hazard.

Modifications will include the addition of supplementary railing elements to increase the overall rail heights while also decreasing the size of the existing openings. Additional pickets will be placed within existing gaps between the decorative scrolls and the length of the balusters will be increased though adding additional material. Knuckles will be used at the joints where the additional material is added to demarcate the original length of the balusters. A base rail will also be added in order to minimize the number of penetrations into the decking, significantly reducing the opportunity of spalling of the terra cotta deck.

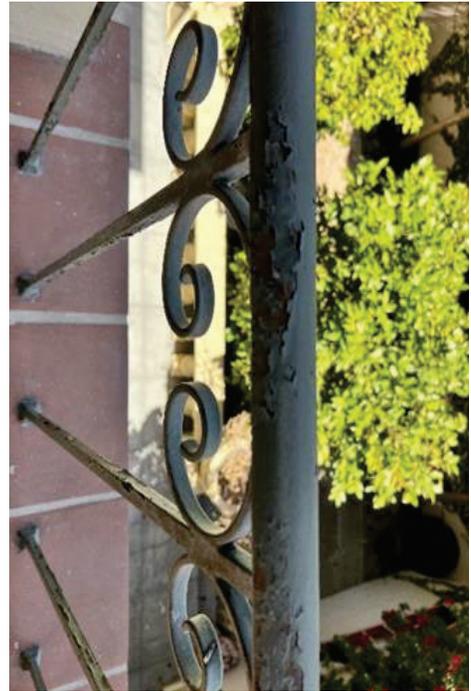
Image 12: Failure of the existing paint coating was also observed. Such loss of the protective coating allows for oxidation of the metal.

Once the railings are removed, the existing paint coating which contains lead will be removed down to bare metal, then primed using a rust prohibitive primer, and painted. The removal of the existing paint finish is to be carried out using the gentlest means possible. JANUS also recommends that the best practices for working with existing lead-based paints be observed.

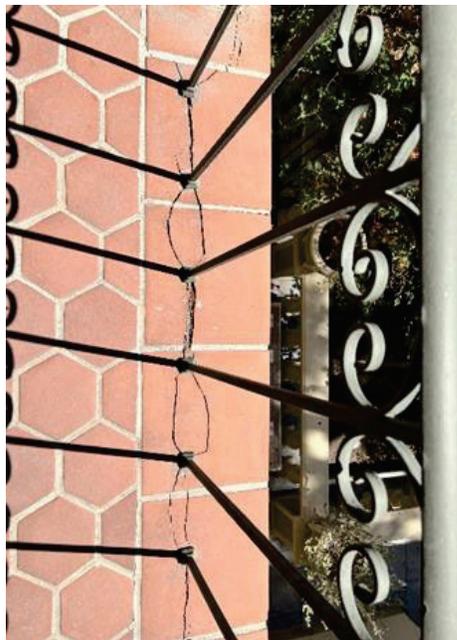
Image 13: Spalling [including losses] was observed where the railing penetrates the concrete coping.

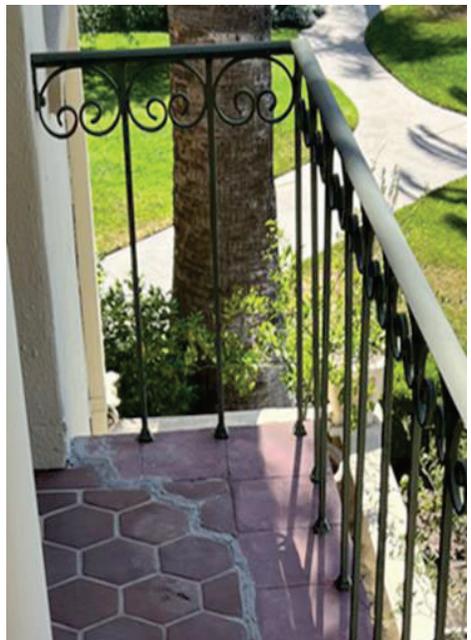
Image 14: Deterioration of the floor surface/ paving has created a reverse slope, preventing accumulated water from freely flowing away from the walking surface.

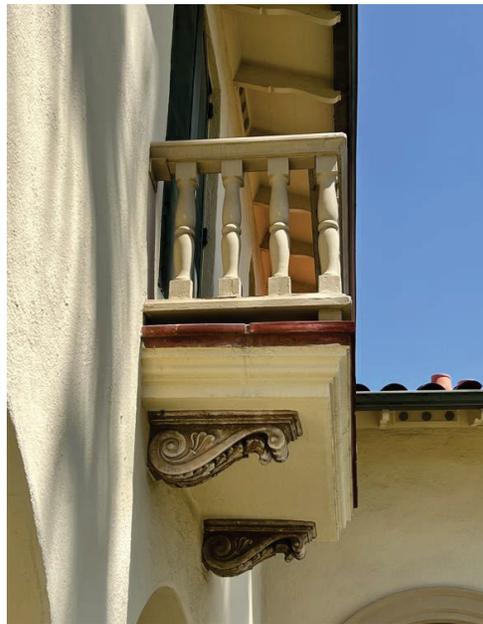
Constructed of wood, the existing balustrade is comprised of a series of turned balusters, with substantial bottom and top rails. The balconies existing paint coatings appear to be near the end of their serviceable life. The coatings have also tested positive for lead content. Areas of the railing exposed to the elements is subject to deterioration.

While the existing guardrails appear to be in serviceable condition, the existing painted finish is deteriorating. The existing paint coatings have also tested positive for lead. The project scope will include the removal of paint down to bare wood followed by an application of primer and paint.

Image 16: Although the railing does not meet current code requirements, the balustrade is in good condition and only requires the removal/replacement of existing paint coatings.

JANUS recommends that the removal of the existing paint finish should be carried out using the gentlest means possible. JANUS also recommends that best practices for working with existing lead-based paints should also be observed.

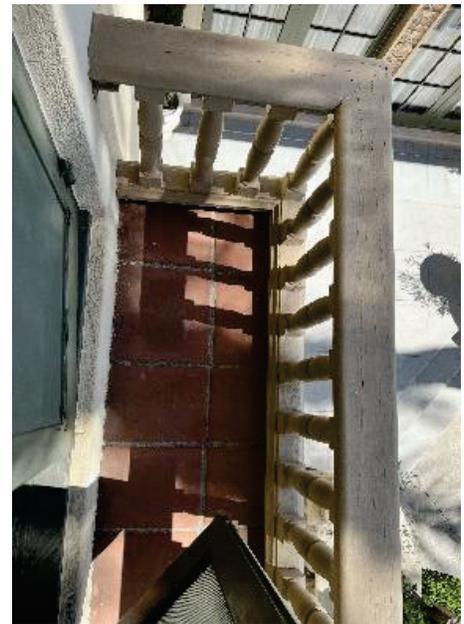
The balcony's terra cotta paving is distinctly unique from the majority of that used in the other balconies, and has perhaps been laid over the original paving surface. Although the existing masonry deck paving may not be original to the home, it does not significantly detract from the historic character of the property. The existing masonry decking also appears to provide adequate sloping to shed water away from the home.

Image 17: The deck's masonry paving appears to be in good condition and currently directs rainwater away for the building.

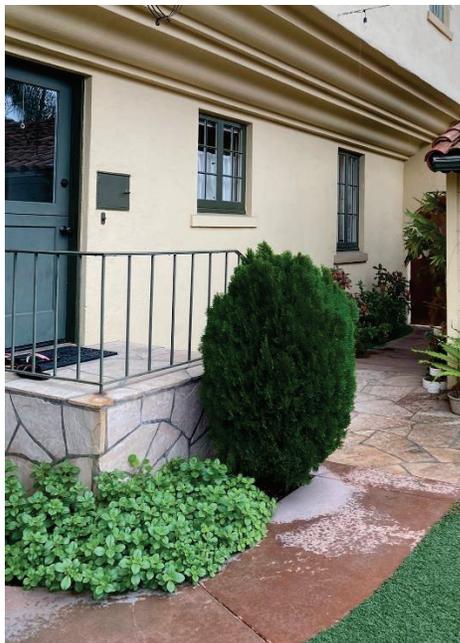
Image 18: The existing rear stoop has been modified through an application of field stone paving.

An existing stoop is present at the rear entry to the home. As no original architectural drawings of the home are known to exist, it is not known if the existing stoop dates from or reflects the original design. While the existing metal handrail may be original to the home, it differs in that it is simpler in design and construction than those located on the home's balconies. Flagstone veneer has been applied to all of the surfaces of the stoop [landing, treads, risers and sides], which is inconsistent with both the style and era of the home.

The project scope includes removal/replacement of the existing stoop. The replacement stoop will be similar to the existing in its overall form, but includes stairs on both the north and south sides of the landing. This change will provide improved access to the rear yard and pool. A solid wall finished in stucco [to match house] will form the outer rail at the landing. Wall mounted iron handrails are also proposed. The landing, treads and risers will be natural, exposed concrete.

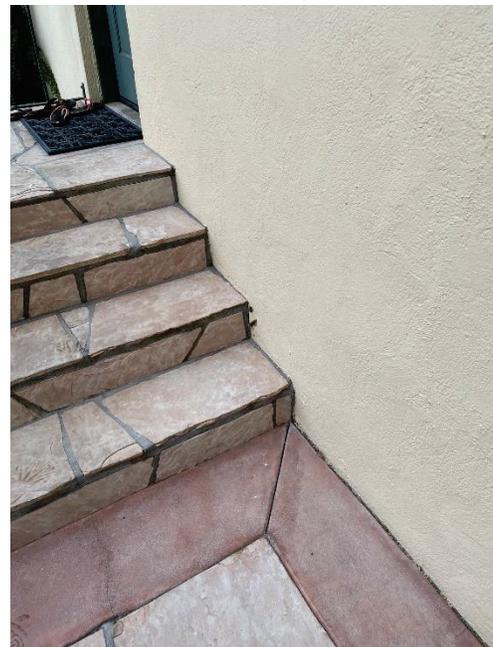
Image 19: Detail image of the rear entry stoop and flagstone paving.

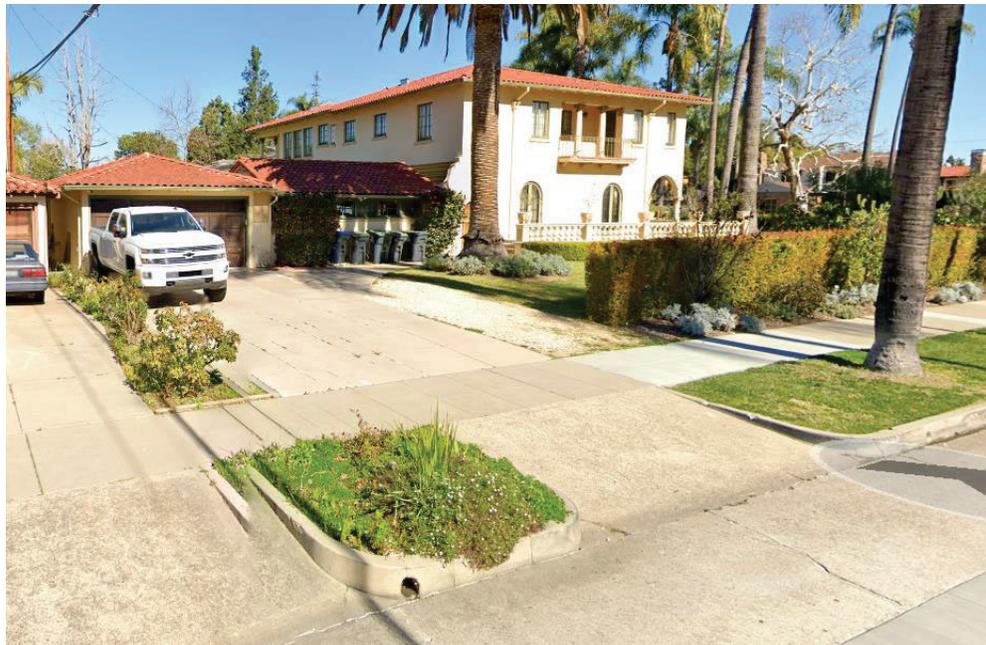
Image 20: The existing driveway as viewed from W. 19th Street.

While portions of the existing concrete driveway may date from the home's era of construction, it has been widened and modified over time to accommodate the multiple-vehicular aspect of contemporary life. Gravel has also been placed adjacent to provide additional off-street parking. Portions of the existing driveway are deteriorating and becoming unsightly

The proposed project includes removal and replacement of the of the existing concrete driveway. The design includes some additional paving to provide access to the proposed new garage space. The distinctive flared scoring of the existing drive will be incorporated into the new driveway. The scoring will be slightly different at the locations beyond the original drive to distinguish the original design. The driveway apron will also be widened to correlate to the new driveway.

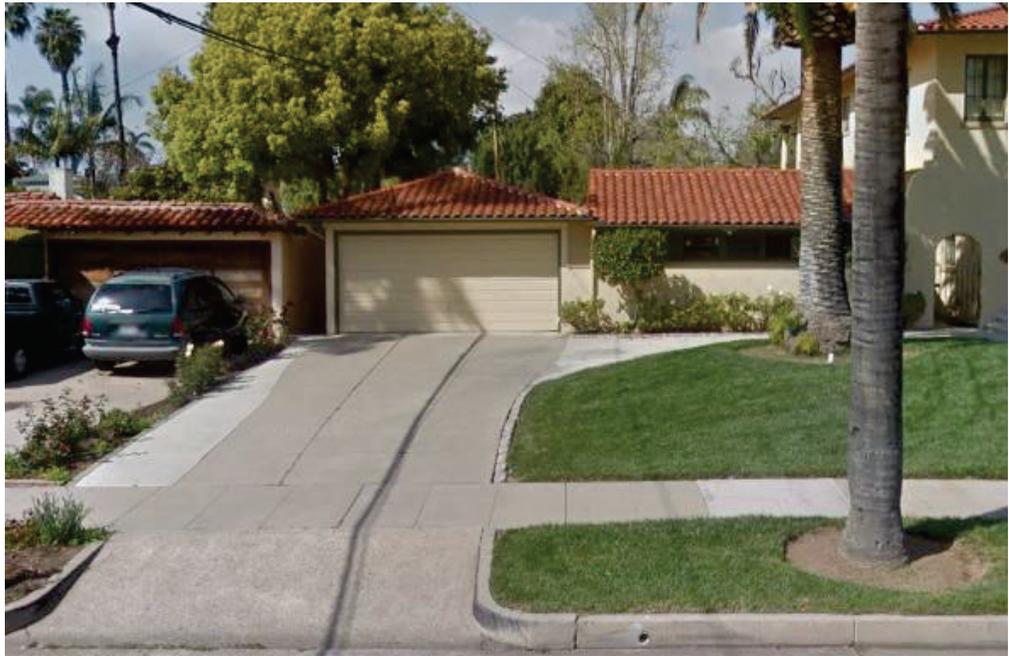
Image 21: 2018 image showing distinctive difference between the old and new concrete visible at both sides of the driveway.

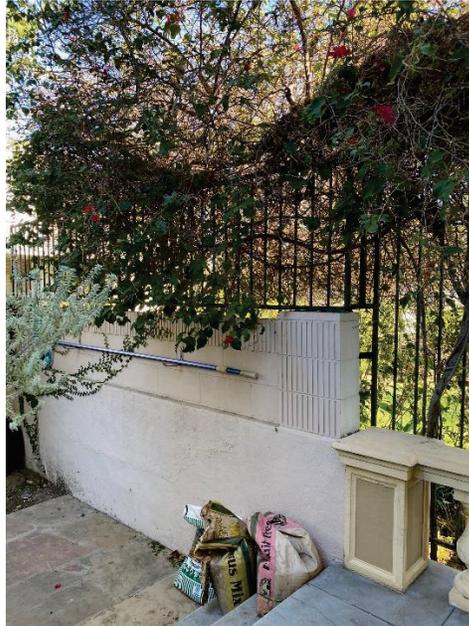
Image 22: Existing masonry wall and security fence.

The west and south boundaries of the rear yard are enclosed with a 6-foot-high masonry wall. Some of the masonry units suggest that the wall was constructed sometime in the post-war period. Iron security fencing has also been installed at the northeast corner of the house. The height of that fencing exceeds the maximum allowable height, and is incompatible with the historic character of the property.

The project includes removal of the iron security fencing. Also included is removal of the masonry wall that spans between the house and the property line at the northeast corner of the home. In its place, a new 6-foot-high masonry wall will be placed with a wooden gate that provides access to the front yard area. The masonry block will be finished with stucco matching the home in color and texture. A three-foot-high entry gate of the same design is proposed along North Heliotrope Street at the front of the property. A proposed pathway of decomposed granite will connect these two gates.

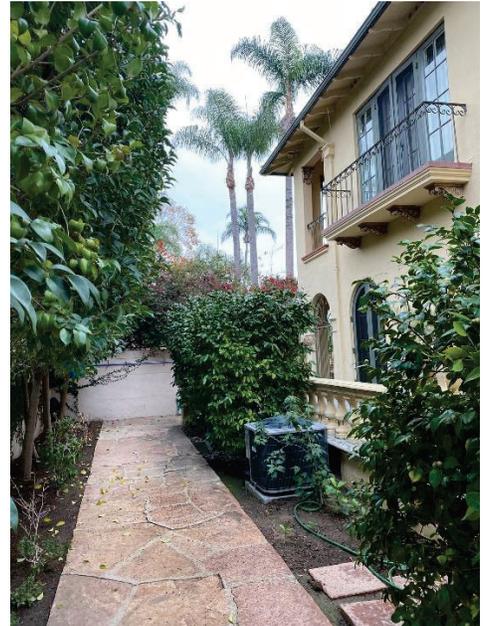
Image 23: Existing masonry wall as viewed from the rear yard.

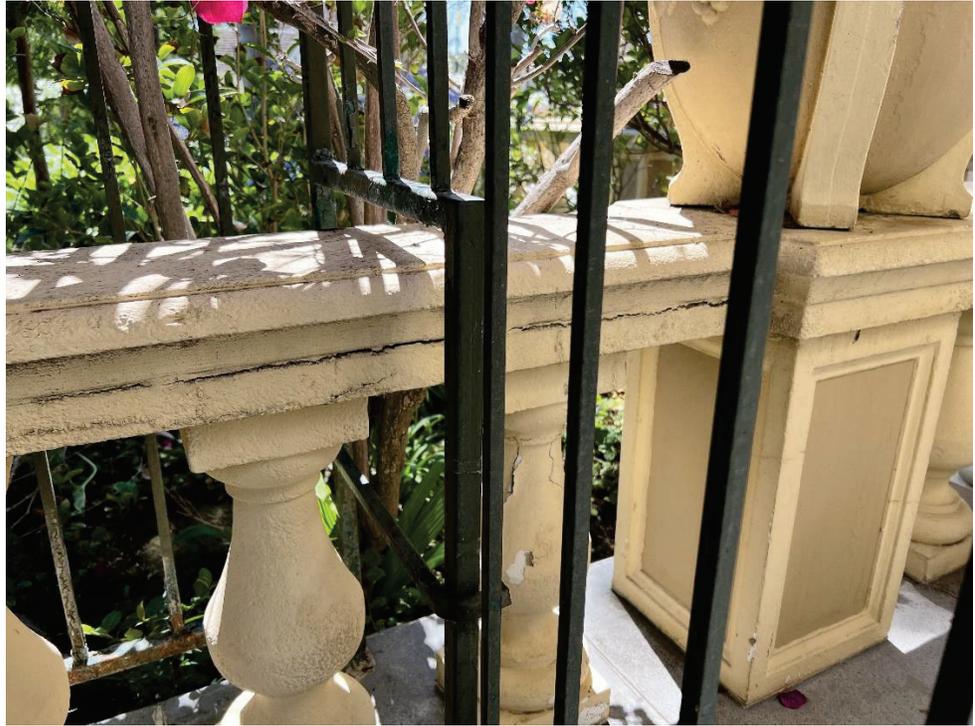
Image 24: Existing non-compatible security fencing.
