T-MOBILE SITE NUMBER:
LA64151A

BU #: 823179
CLAYTON - HALLADAY ST

2929 HALLADAY ST
SANTA ANA, CA 92705

EXISTING 53'-0" MONOPINE

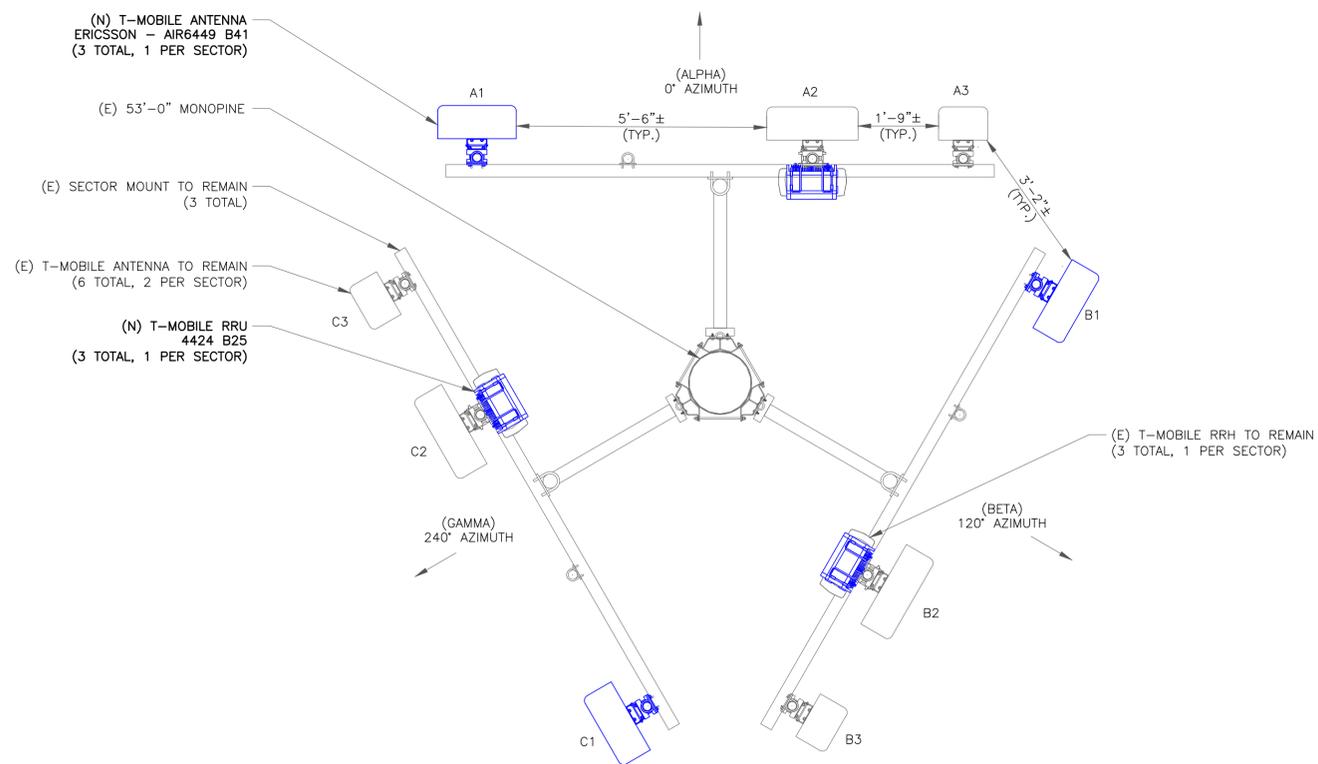
2 NEW ANTENNA PLAN
SCALE: NOT TO SCALE

1. REFERENCE C-4 FOR FINAL EQUIPMENT SCHEDULE.
2. REFERENCE C-5 FOR NEW EQUIPMENT SPECIFICATIONS.
3. CONTRACTOR TO VERIFY ALL ANTENNA TIP HEIGHTS DO NOT EXCEED BEACON BASE HEIGHT.
4. PAINT NEW EQUIPMENT TO MATCH EXISTING. INSTALL ANTENNA SOCKS
